**Re: Quarterly Progress Report – Second Quarter 2022**  
**Closure Approval No. LCB220001**  
**Facility No. 132708**  
**IAOC C1 Ground Water and Soil Remediation Projects**  
Former Tank 319 Waterfront Landfill Area (IAOC C1) – Block 586, Lot 17  
Bayway Refinery Complex  
1400 Park Avenue  
City of Linden, Union County, New Jersey

Figure 1 – IAOC C1 Ground Water Remediation Project Summary as of June 30, 2022

Figure 2 – IAOC C1 Soil Remediation Project Summary as of June 30, 2022

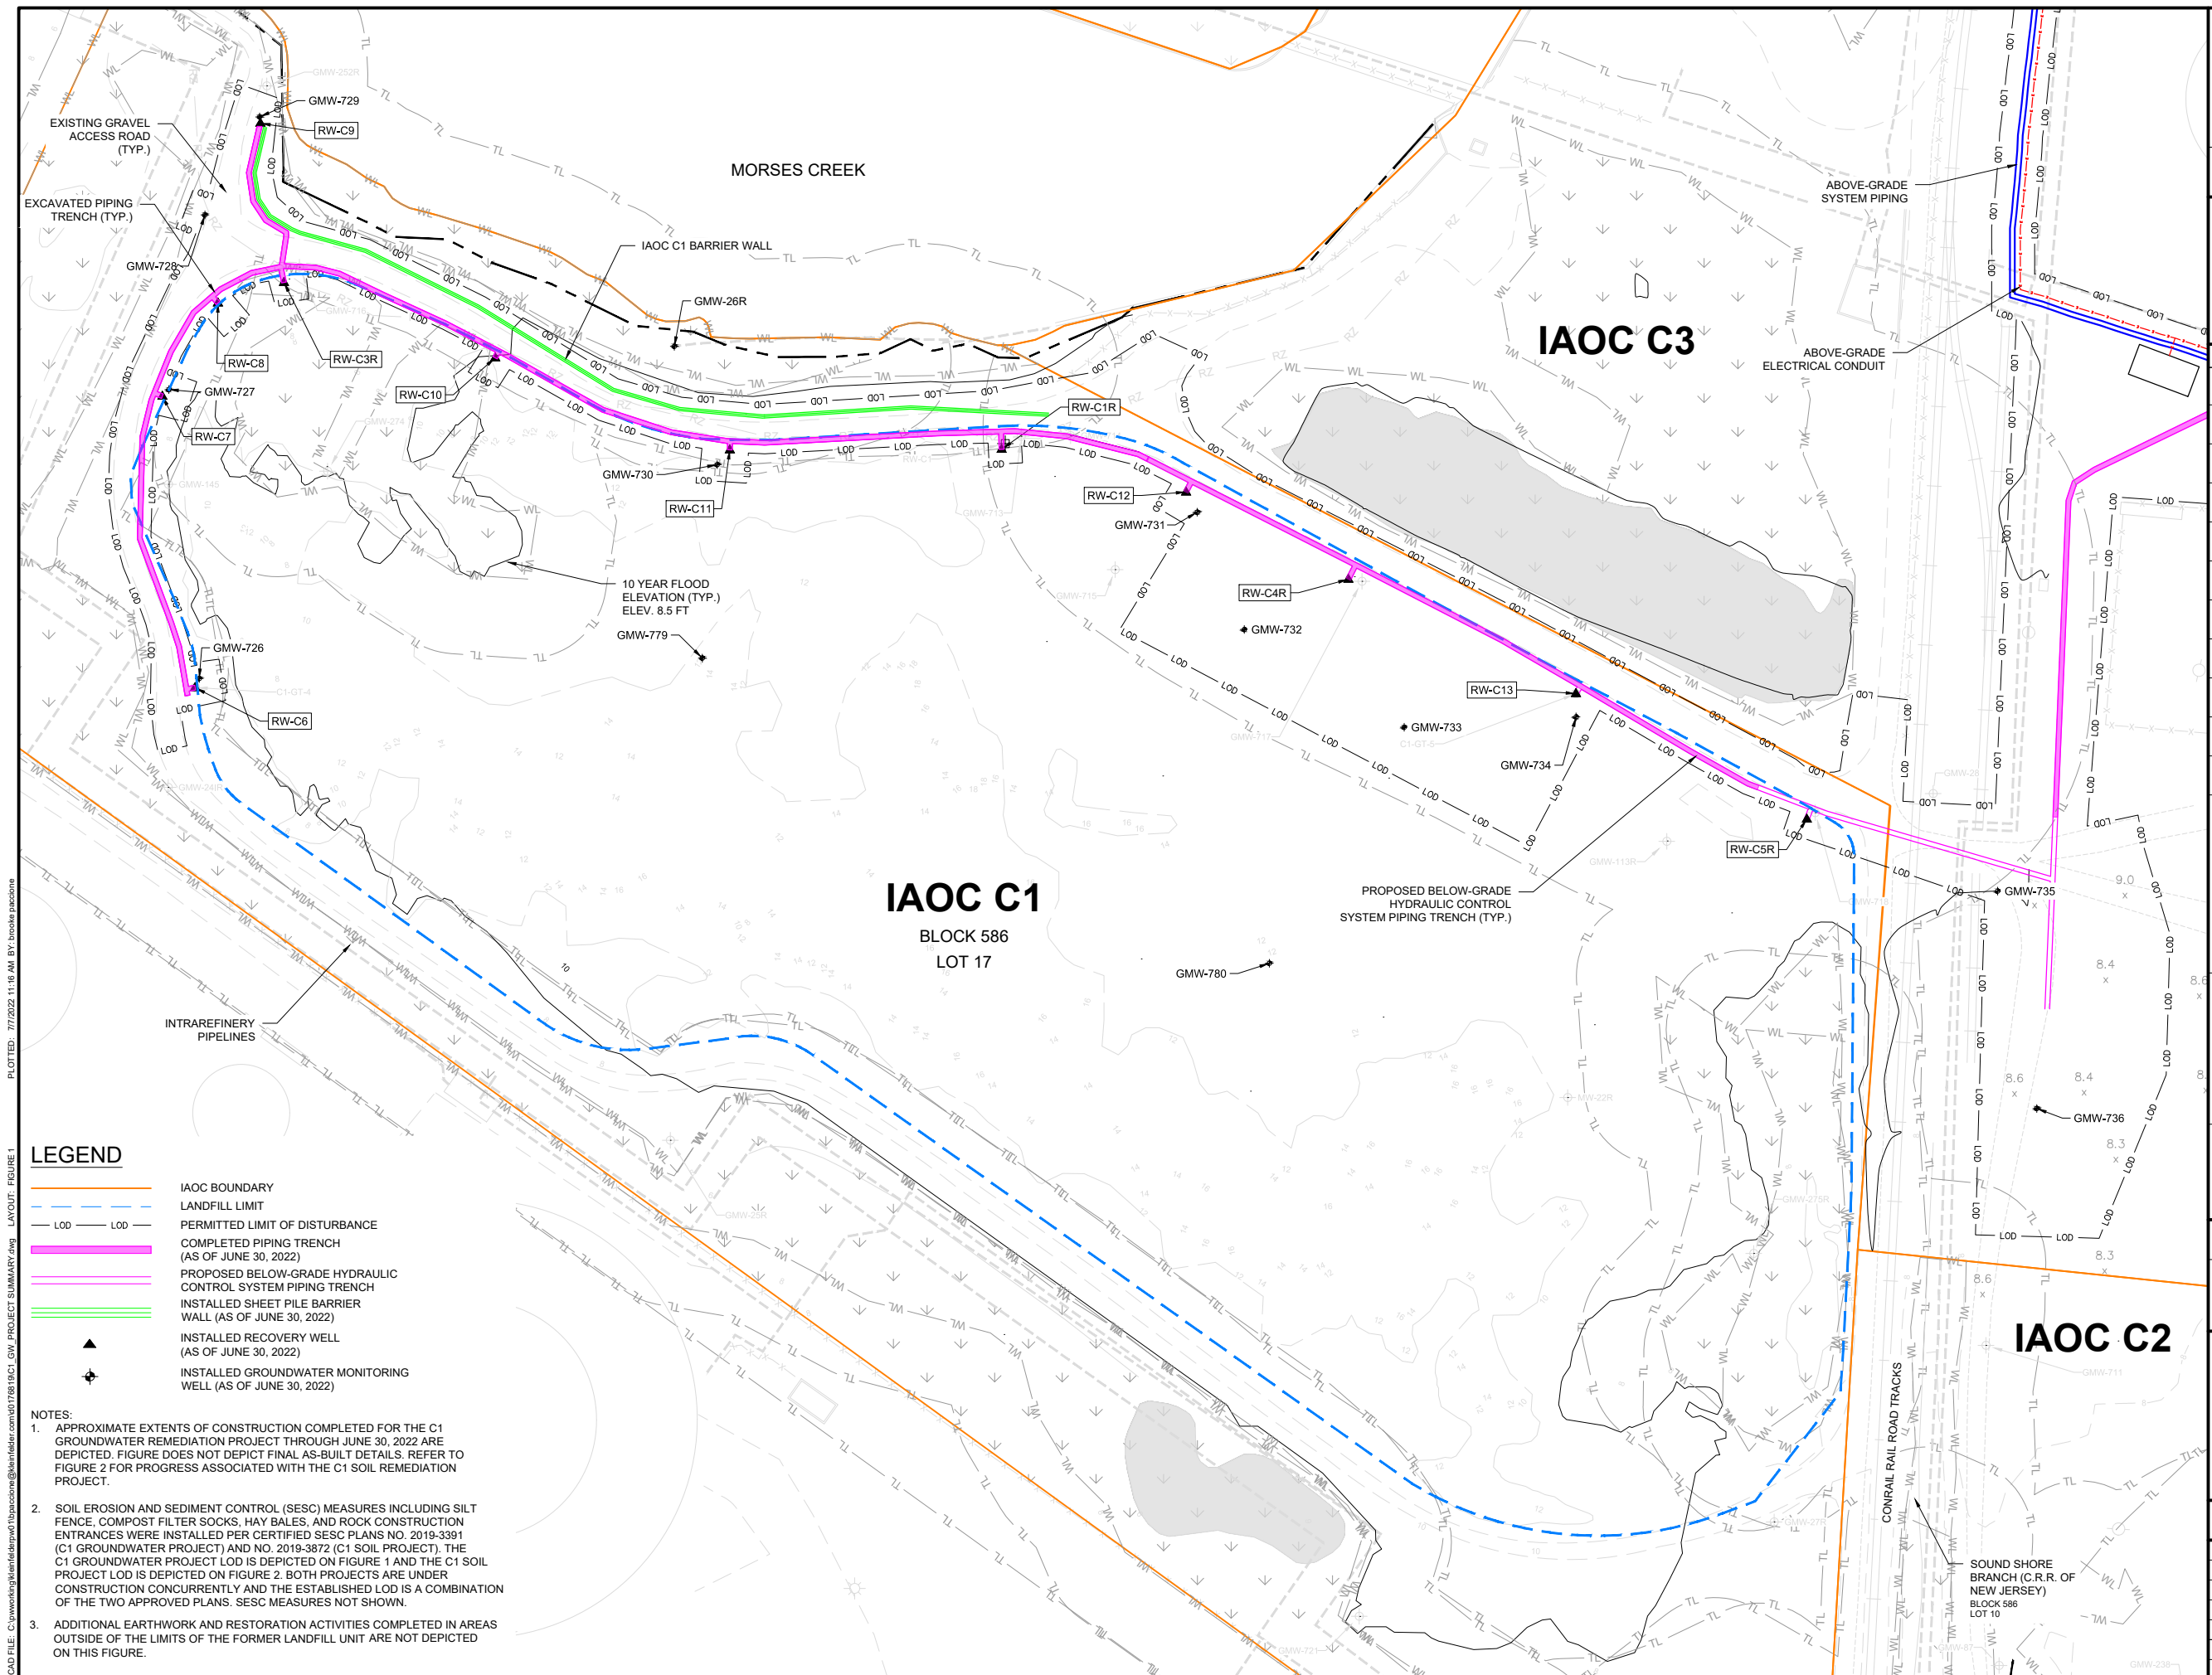
FIGURE 1

Construction of the ground water remedial action was initiated in late 2019. Figure 1 is a plan view of the IAOC C1 area that depicts the IAOC C1 boundaries, the limits of the former landfill unit, and the proposed locations of the ground water remedial action components listed above. Where applicable, the construction status of the various components is also highlighted or otherwise indicated. Figure 1 does not reflect as-built conditions. For reference, the information provided on Figure 1 reflects the status of all proposed ground water remedial action construction activities within IAOC C1, including activities within and outside of the landfill limits.

- Clearing and grubbing within the limits of disturbance (LOD) shown on Figure 1 is complete.
- SESC measures have been implemented and continue to be maintained in accordance with certified SESC Plan No. 2018-3391.
- Construction stormwater is being managed and the SESC measures continue to be maintained and inspected per the SESC Plan requirements, the certified Stormwater Pollution Prevention Plan (SPPP), and Individual Stormwater Permit Authorization No. NJ0297755. Weekly SPPP inspections were completed during this reporting period.
- The IAOC C1 steel sheet pile wall, which is located outside of the limits of the former landfill, is installed in its entirety (approximately 575 linear feet). Following advancement, the tops of the sheets were cut to a consistent elevation just below existing grade and backfilled.
- Wells GMW-26, RW-C1, RW-C3, RW-C4, and RW-C5 were properly abandoned.

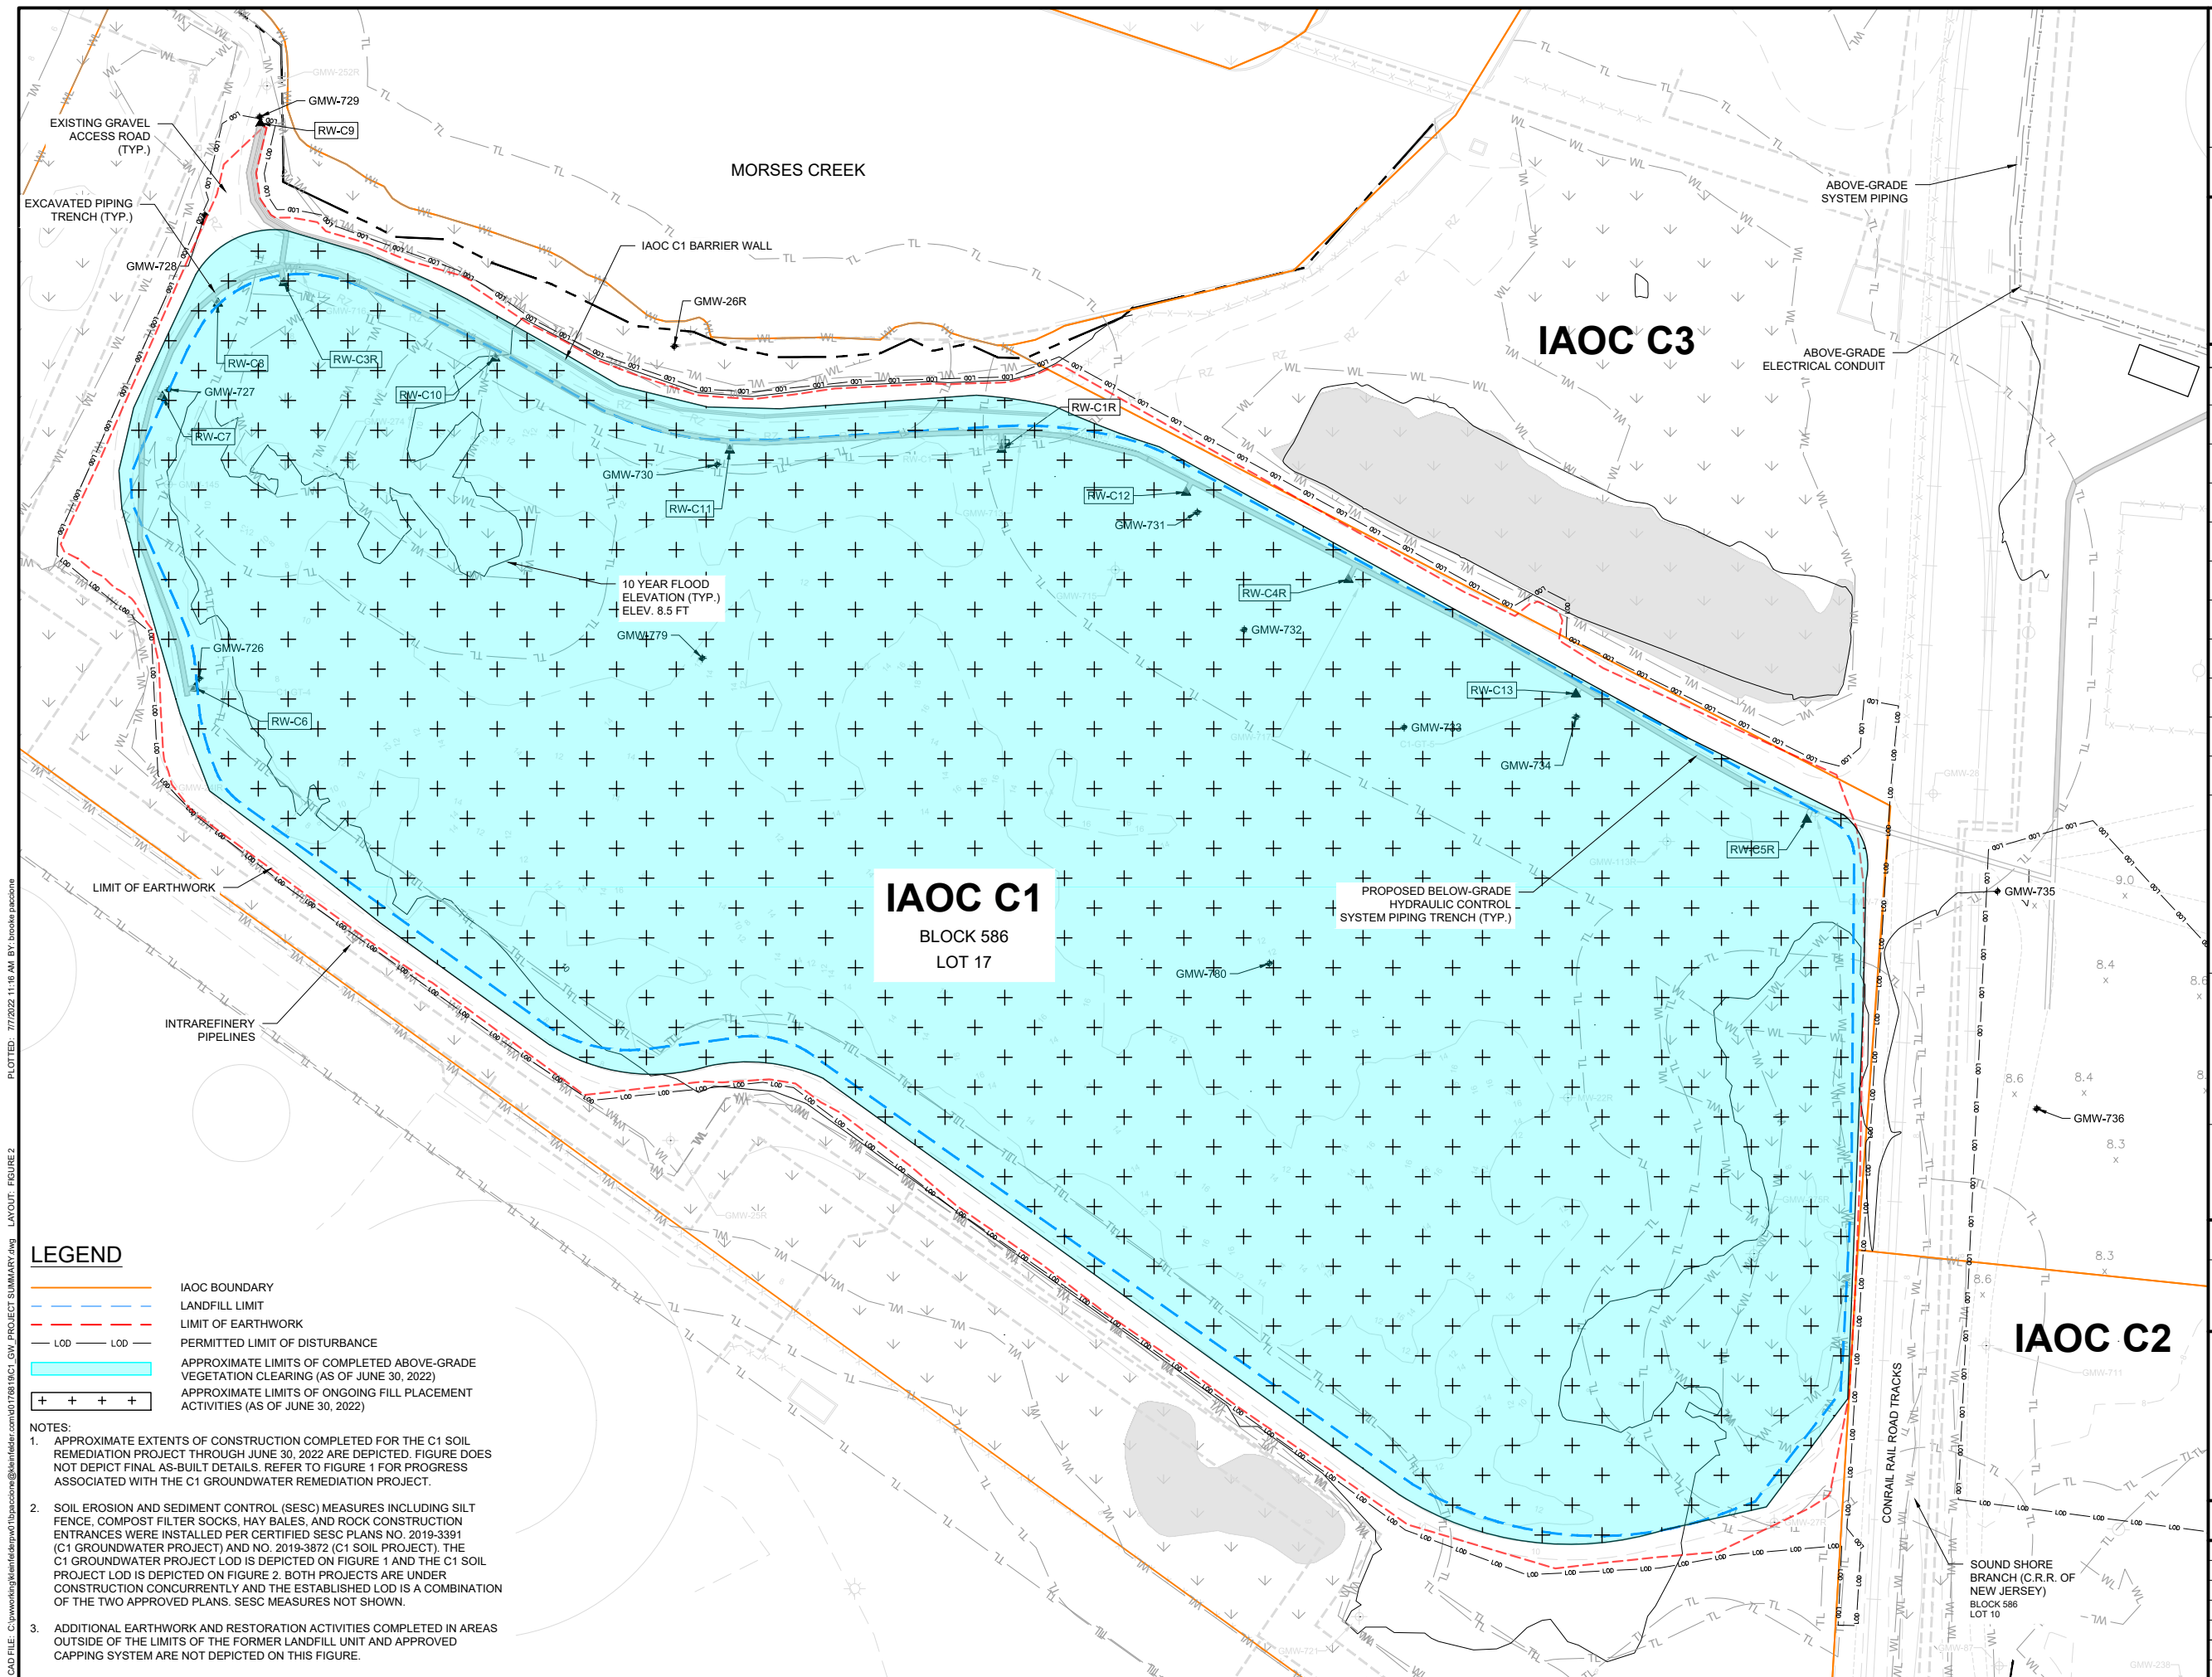
FIGURE 2

With the issue of the Closure and Post-Closure Plan Approval dated August 27, 2020, permitting for the IAOC C1 Soil Remediation Project is complete. Construction activities associated with the IAOC C1 Soil Remediation project were initiated in the first quarter of 2021. Figure 2 is a plan view of the IAOC C1 area that depicts the IAOC C1 boundaries and the limits of the former landfill unit. Where applicable, the construction status of the various components is also highlighted or otherwise indicated. Figure 2 does not reflect as-built conditions.

**IAOC C1 SOIL REMEDIATION PROJECT SUMMARY**  
**AS OF JUNE 30, 2022**

- Perimeter air monitoring activities have been conducted in general accordance with the approved Perimeter Air Monitoring Plan.
- Clearing of above-grade vegetation within the limits of the landfill shown on Figure 2 is complete.
